WA-I-507 Brick House

Maryland Historical Trust State Historic Sites Inventory Form

Survey	No.	WA-I-507
--------	-----	----------

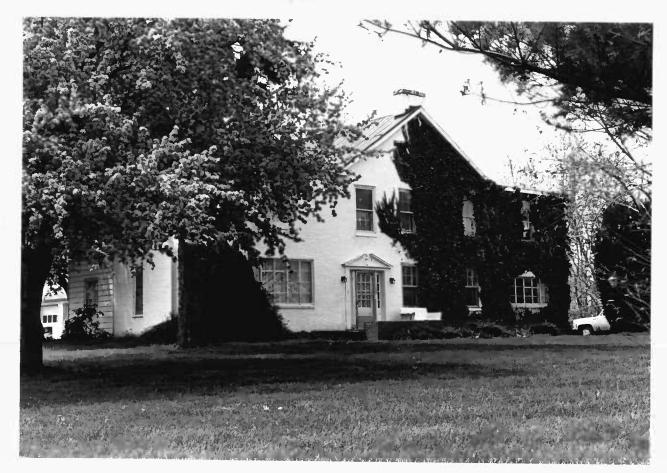
- Brick House WA-I-507 1. Washington County, Maryland
- 3. Joe Getty
- 4. May 1983 5.
- Maryland Hist. Trust, Annapolis, Md.
- 6. East Elevation; camera facing northeast 7. 1/1
